Manhole Inspection Summary

Manhole # S21A1_011MH

Insp Date: **5/18/08 12:26 PM**

Location Address: **2300 paca st**

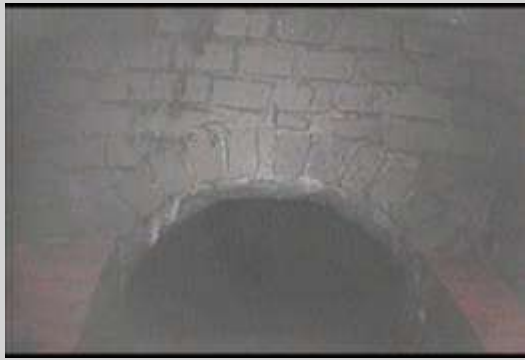
12 O'Clock Outflow

24 in. Circular Gravity Sewer
Pipe Out @ 12 O'Clock

Pipe Height: **24** (in.) Rod and Bar (Angled)
Pipe Material: **Clay** ☐ Pipe Lined
Invert Depth: **22.60** (ft.) Flow Characteristics: **Fast**
Deposits: ☒ None ☐ Mud ☐ Sludge ☐ Debris ☐ Grease
Silt Depth: **0** (in.) Deposits Extent:
Infiltration: **None** Pipe Seal Cond: **Sound**

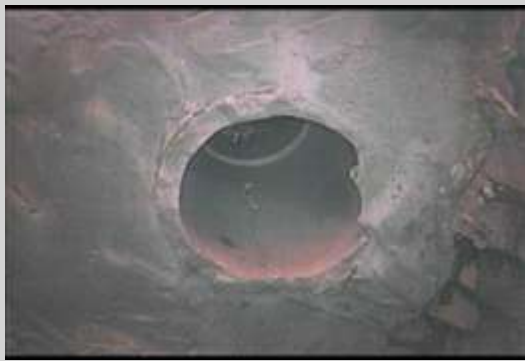
3 O'Clock Inflow

8 in. Circular Gravity Sewer
Pipe In @ 3 O'Clock

Pipe Height: **8.4** (in.) Rod and Bar (Angled)
Pipe Material: **Clay** ☐ Pipe Lined
Invert Depth: **12.05** (ft.) Flow Characteristics: **Fast**
Deposits: ☒ None ☐ Mud ☐ Sludge ☐ Debris ☐ Grease
Silt Depth: **0** (in.) Deposits Extent:
Infiltration: **None** Pipe Seal Cond: **Sound**

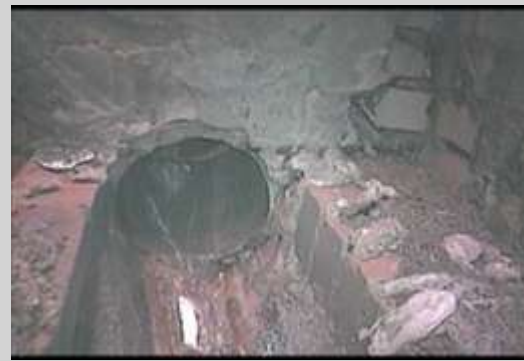
Drop In @ 3 O'Clock

Drop: **Inside** Rod and Bar
Angled: **Yes** Reading: **12.54** (ft.)
Inv Depth: **13.54** (ft.)
Drop Condition: **Open**

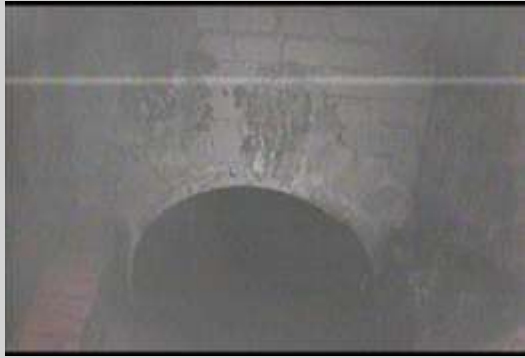
6 O'Clock Inflow

24 in. Circular Gravity Sewer
Pipe In @ 6 O'Clock

Pipe Height: **24** (in.) Rod and Bar (Angled)

Infiltration: **None** Pipe Seal Cond: **Sound**
